REPORT: FE-05-97

RAILROAD: Consolidated Rail Corporation (CR)

LOCATION: Burns Harbor, Indiana

DATE, TIME: Feb. 2, 1997 at 9:55 p.m., EST

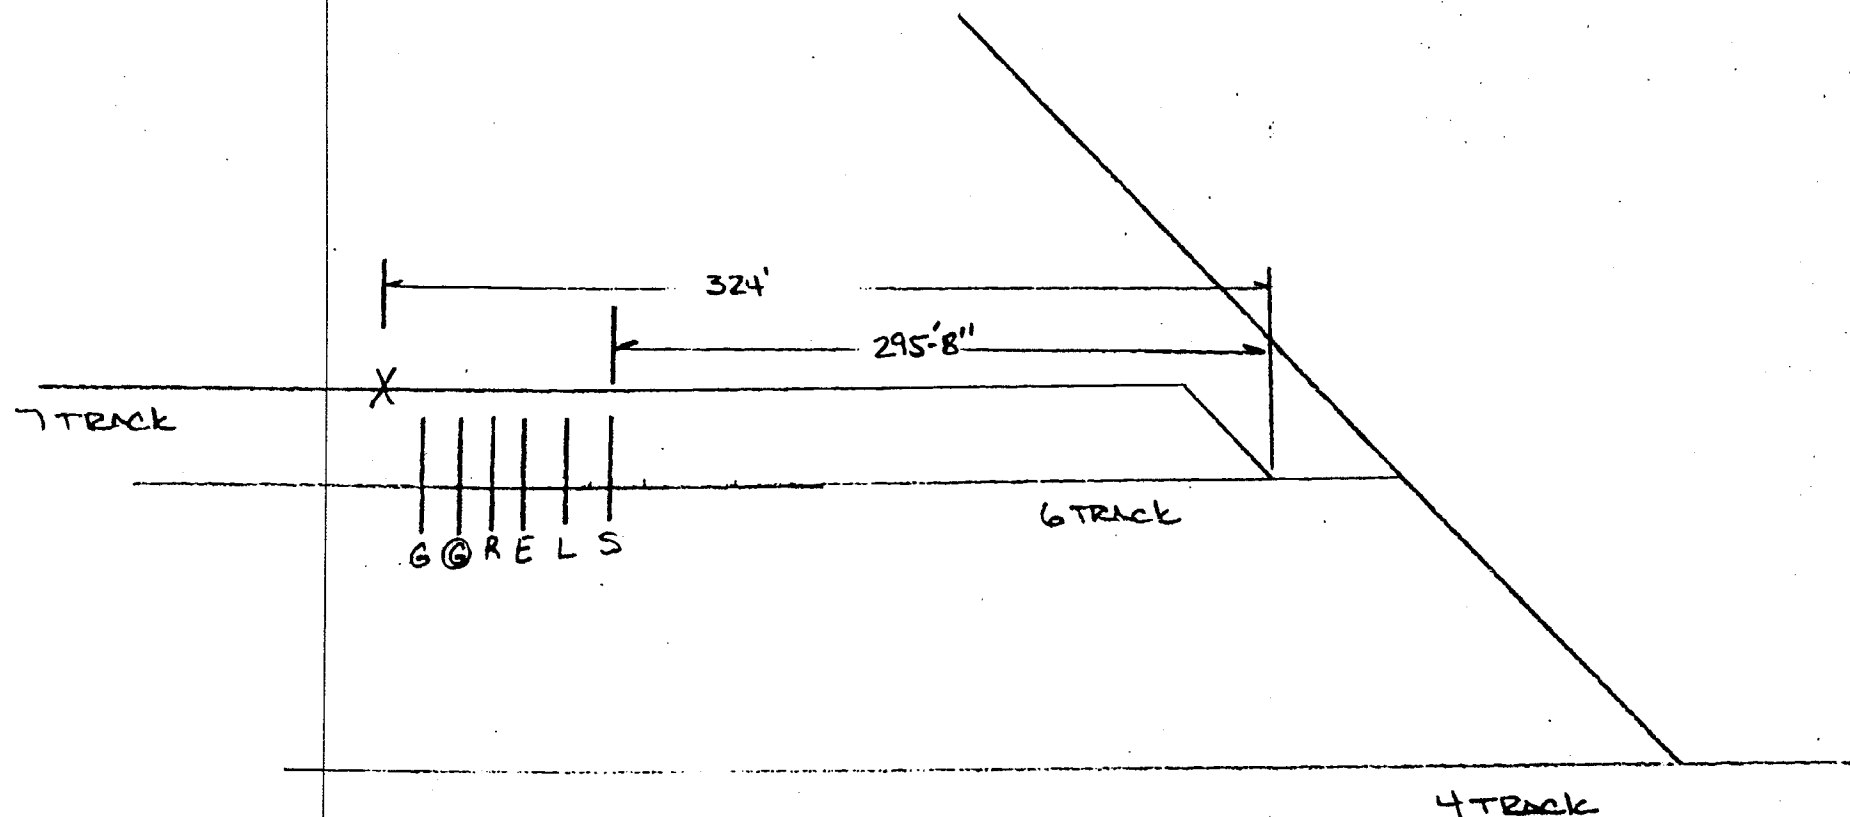
MOVEMENT OF TRAIN
WEST INTO #7 TRACK

INJURED
Employee
Found

POINT OF
CONTACT

CAR-INSPECTION
REPORT MADE OUT
ON - OTX 91321 ONLY
